**ARMOR**  
TENNIS COURT CRACK REPAIR SYSTEM

# THE ARMOR® SYSTEM

A Patented Process for  
Long-Term Repairs to  
Asphalt Tennis Court Cracks

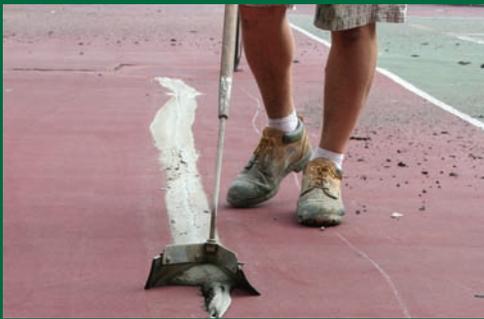
STEP 1: Fill cracks up to 4 inches wide

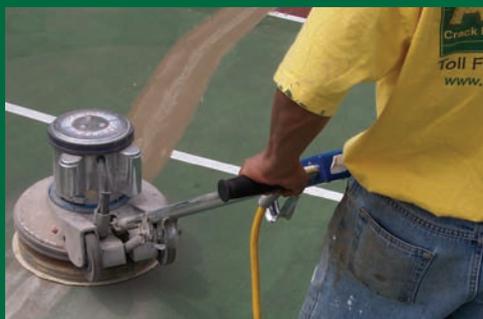
STEP 2: Sand flush to surface

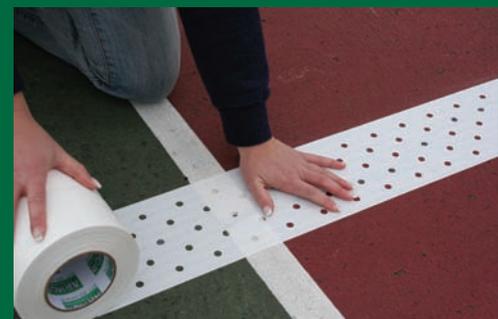
STEP 3: Apply ARMOR® release tape

The ARMOR® Crack Repair System utilizes a knitted fabric that will expand as the crack widens. The secret to making this repair work is how it is purposely NOT bonded to the court in the vicinity of the crack, thereby allowing more of the fabric to absorb any movement or growth of the crack without the fabric tearing or delaminating from the surface. Thus, the reason why the ARMOR™ Crack Repair System works so well is that it effectively spreads the stress of the crack over a wide area of expandable fabric—**other brand name repair "systems" do not employ the ARMOR® slipsheet technology.**

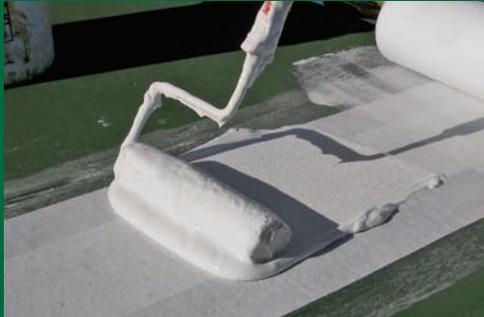
STEP 4: Apply liquid adhesive

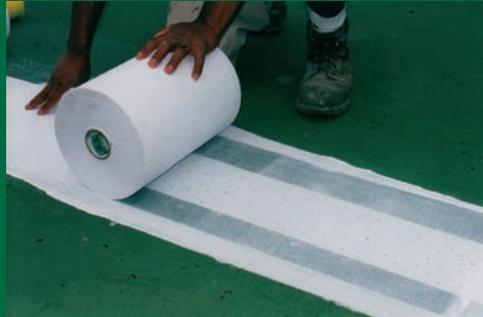
STEP 5: Install narrow ARMOR® fabric

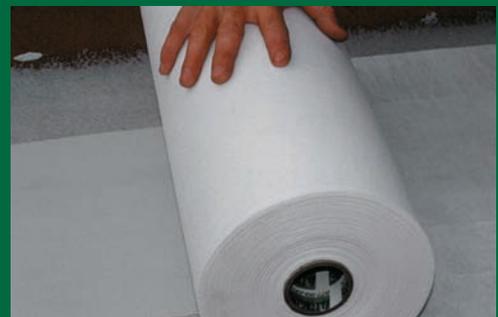
STEP 6: Install wide ARMOR® fabric

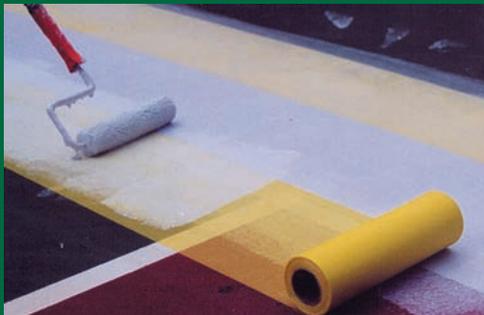
STEP 7: Install yellow ARMOR® mesh

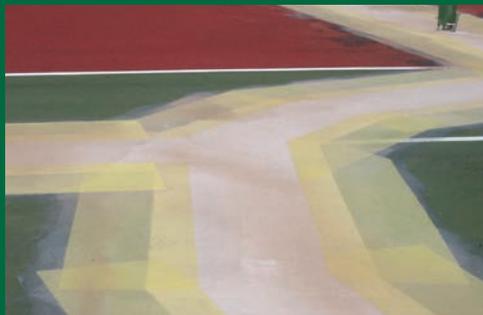
STEP 8: Finished...ready to color coat!

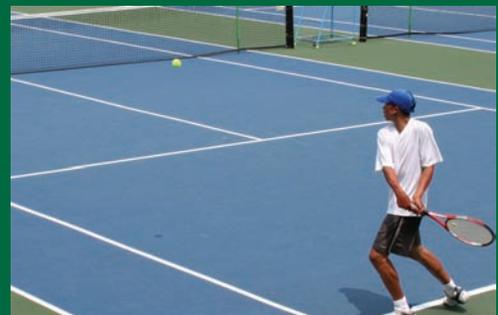
Crack-Free Surface...Ready for Play!
